*Airfield Damage Repair Modernization Program*

## **AM2 Mat End Connector Modeling and Performance Validation**

August 2015

Final report

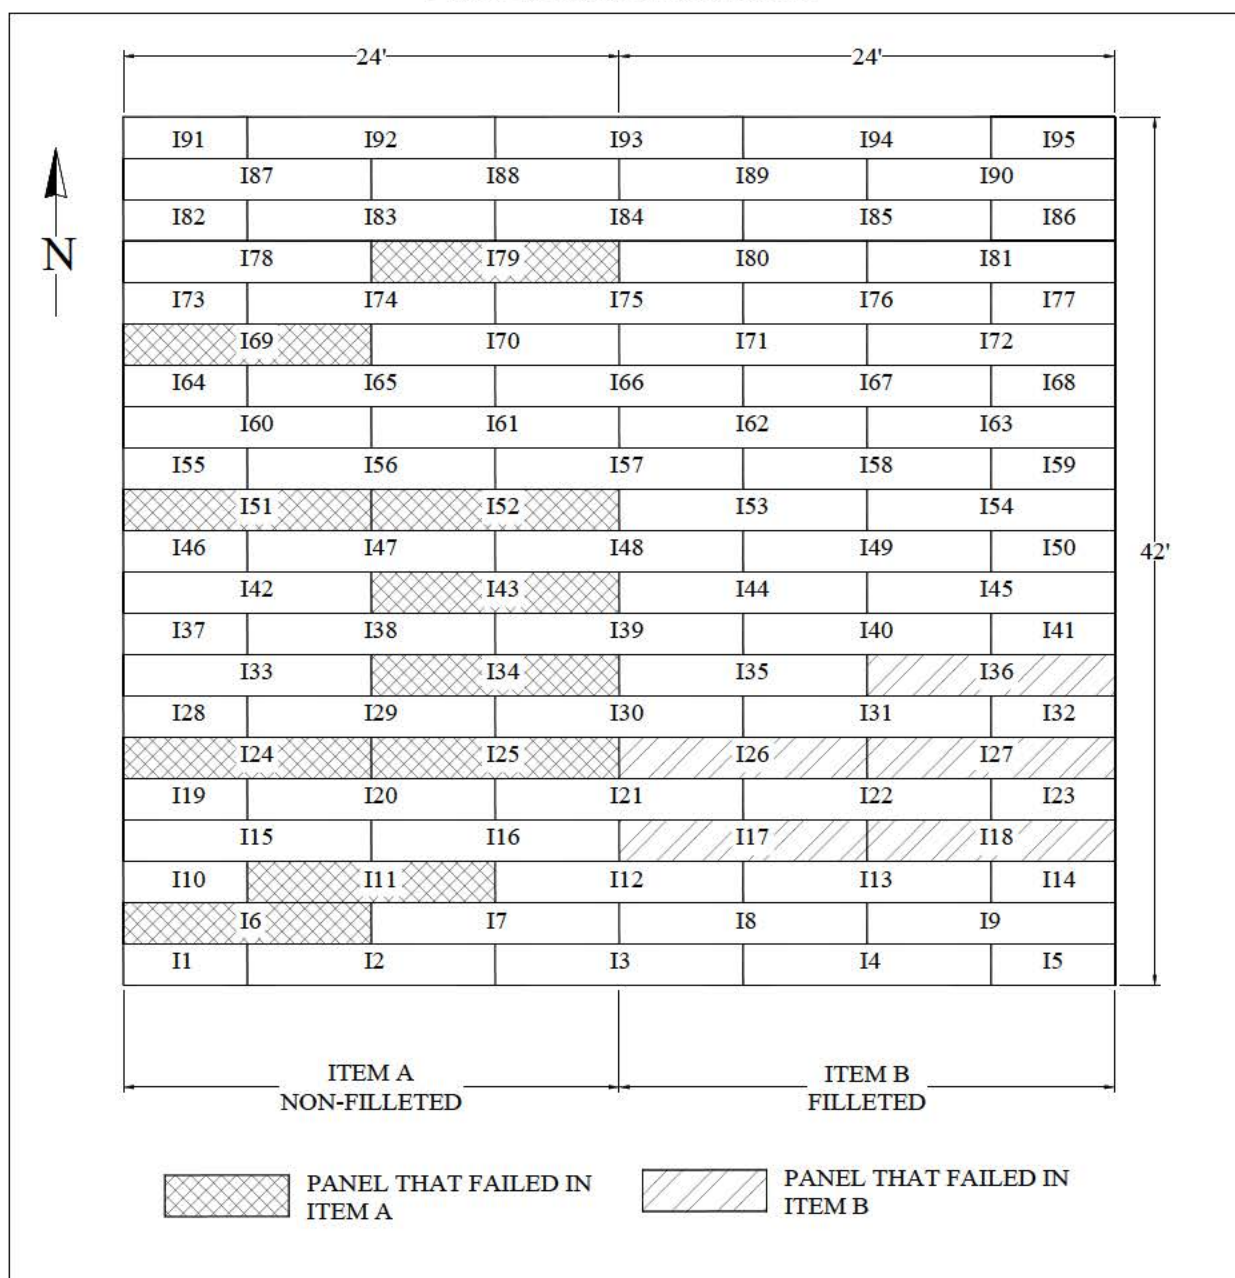
The following sections describe all mat breakage and the behavior of the AM2 airfield mat. Figure 26 shows the layout of failed panels in each test item.

Figure 26. Layout of failed panels.

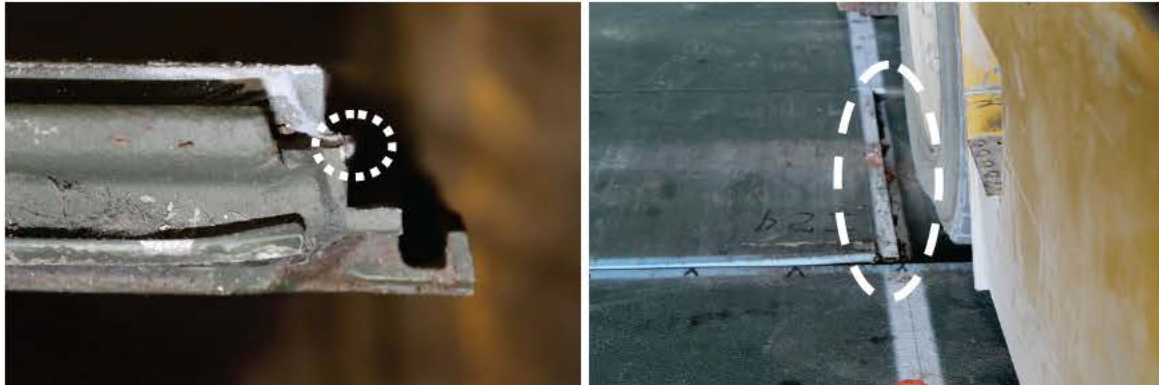
The most common mat breakage was broken upper underlap rails (Figure 27). When a rail failure occurred, separation was noted at the adjoining panels as the load cart passed over the joint. Upper underlap rail failure was confirmed when a crack could be seen at the rail from the

Figure 27. Broken upper underlap rail I-79 (left) and I-25 (right).

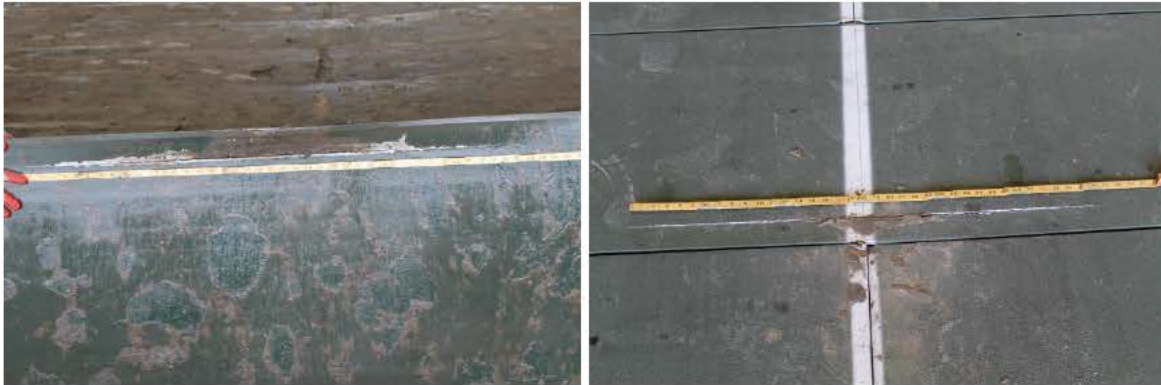
I-11	Crack along face of female hinge, 50 in. long. Crack on bottom skin, 40 in. long, 2.5 in. from edge of bottom flange of female hinge.	-	-	
	I-6	Crack at end connector weld from top surface to bottom surface that extended 3 in. on bottom skin	-	-	
	I-2	Crack along male hinge, 9 in. long	-	-

Figure 31. Crack on bottom (left) and top (right) surface of I-11.

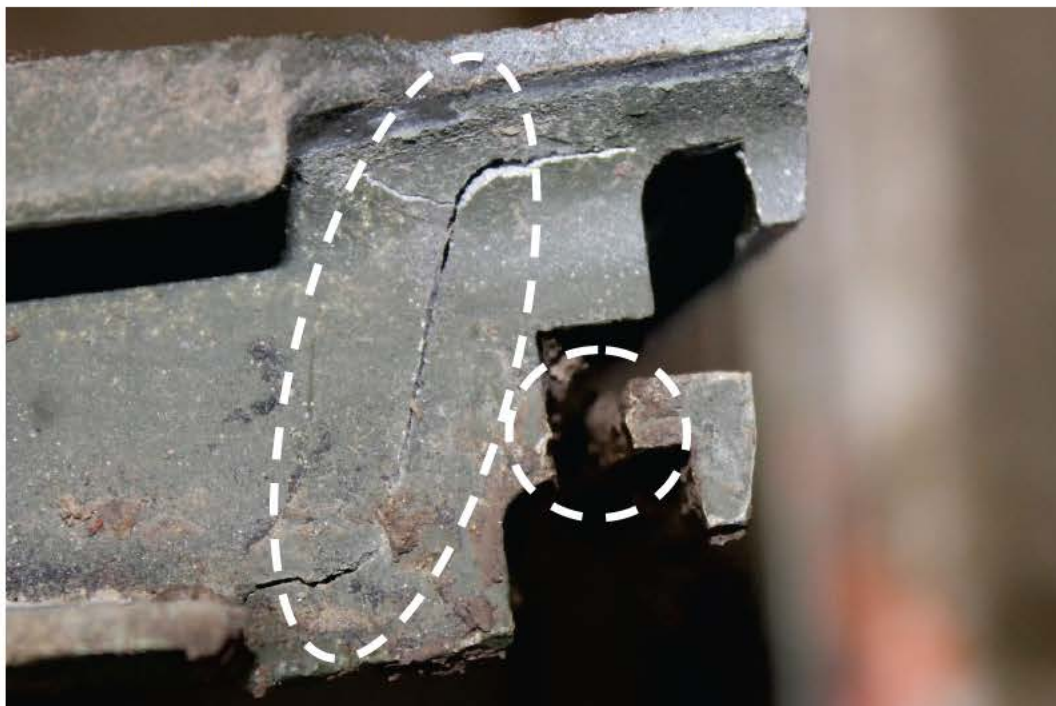
Figure 32. Crack at weld and broken lower overlap rail at I-42.

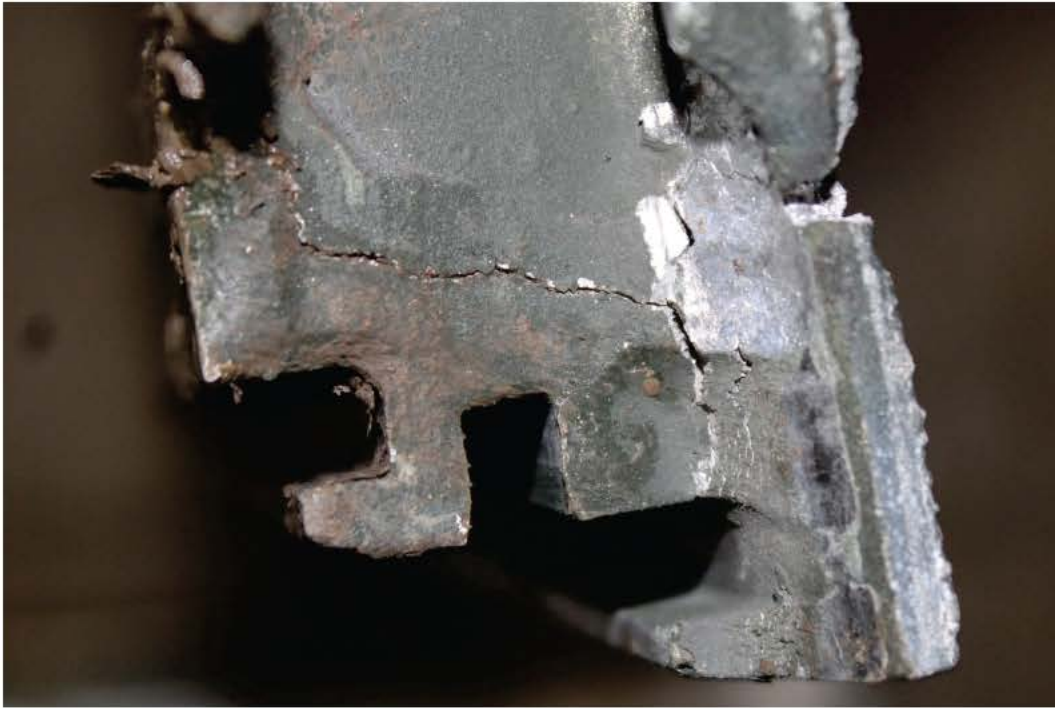
Figure 36. Crack at weld of I-62.

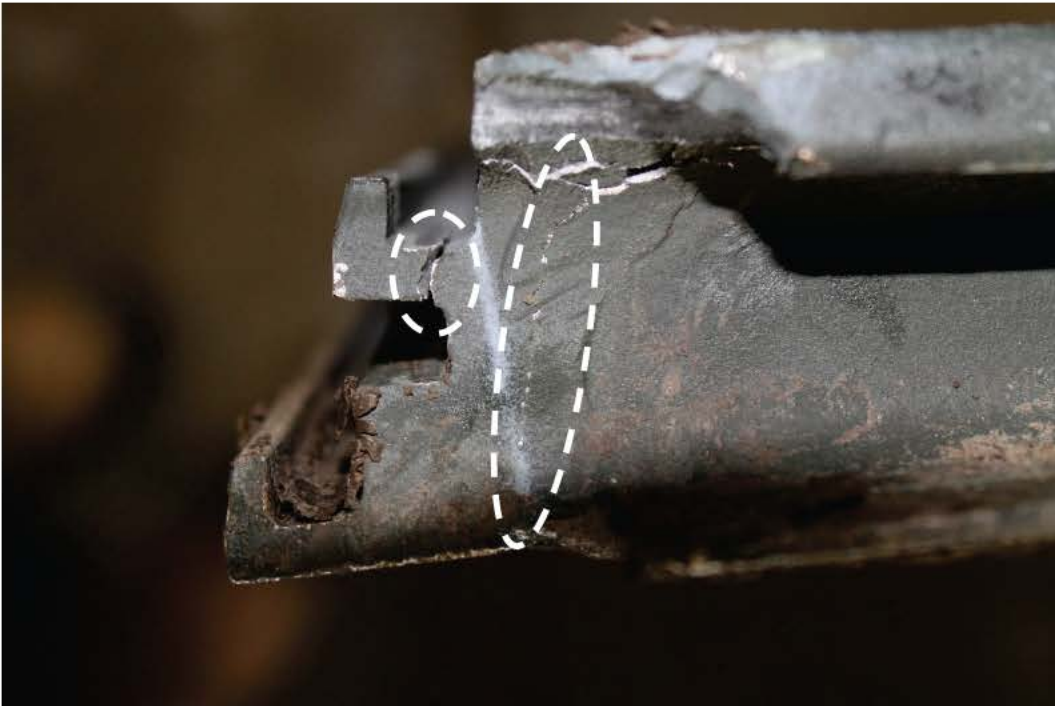
I-58	Crack along face of female hinge, 15.5 in. long	-	-	
	I-54	Upper underlap rail broke length of 3 in., starting at female hinge. Hairline crack at weld.	-	-	
	I-53	Minor cracking at top of weld of end connector	-	-	
	I-44	Crack at weld of end connector from top surface to bottom surface that extended 1.75 in. on bottom skin	-	-

Figure 37. Cracked upper underlap rail and hairline crack at weld of I-54.
